# **PRESERVATION ASSESSMENT OF THE ELM STREET CEMETERY, BRAINTREE, MASSACHUSETTS**

**Chicora Research Contribution 529**

Prepared By:  
Michael Trinkley, Ph.D.  
Debi Hacker  
and  
Nicole Southerland

September 2010

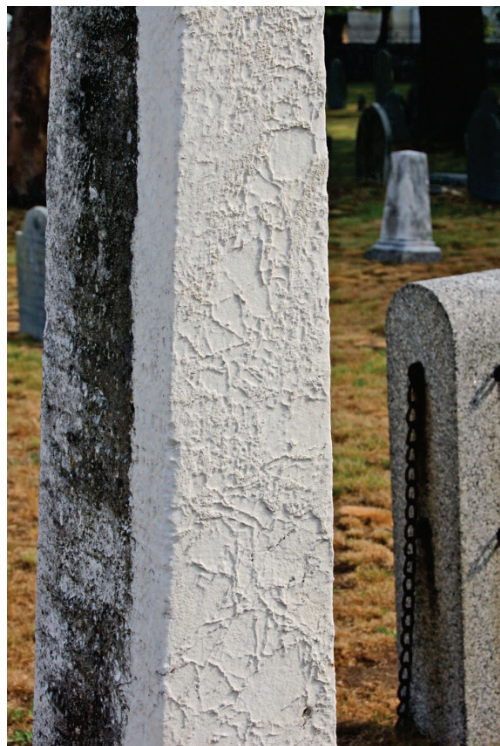
Figure 48. Weathering of marble showing the erosion of the stone with veins of harder stone standing “proud.”
